Acceleration Monitoring for Tool Condition in Large-Volume Vibratory Mills

Abstract

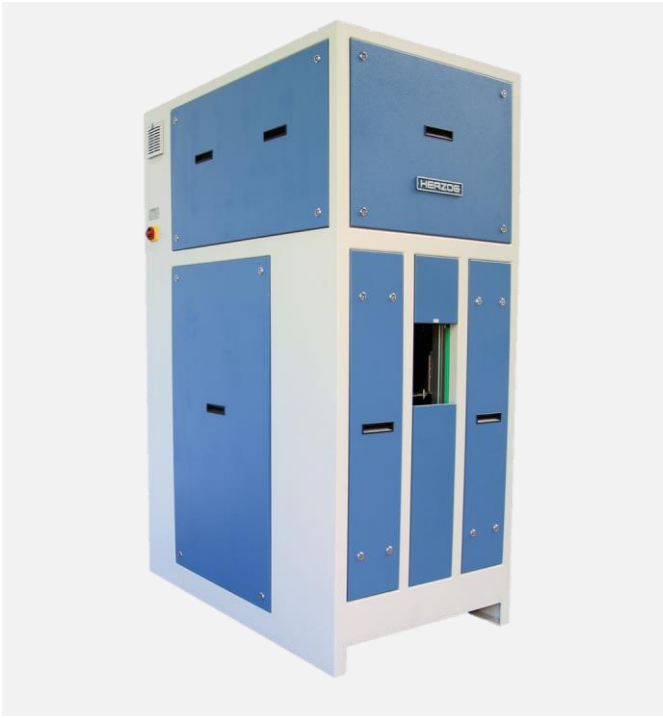
Figure 1: Photographs of the vibratory disc mill of the type HP-M 1500 with a 1500 ccm grinding vessel

In this application note, we focus on the HP-M 1500 (Figure 1), which has a elaborated swing aggregate to manage the heavier grinding vessel with a volume of 1500 ccm. The system employs 16 vertical springs, four upper horizontal tension springs, and four lower horizontal tension springs to maintain optimal motion (Figure 2, 3).

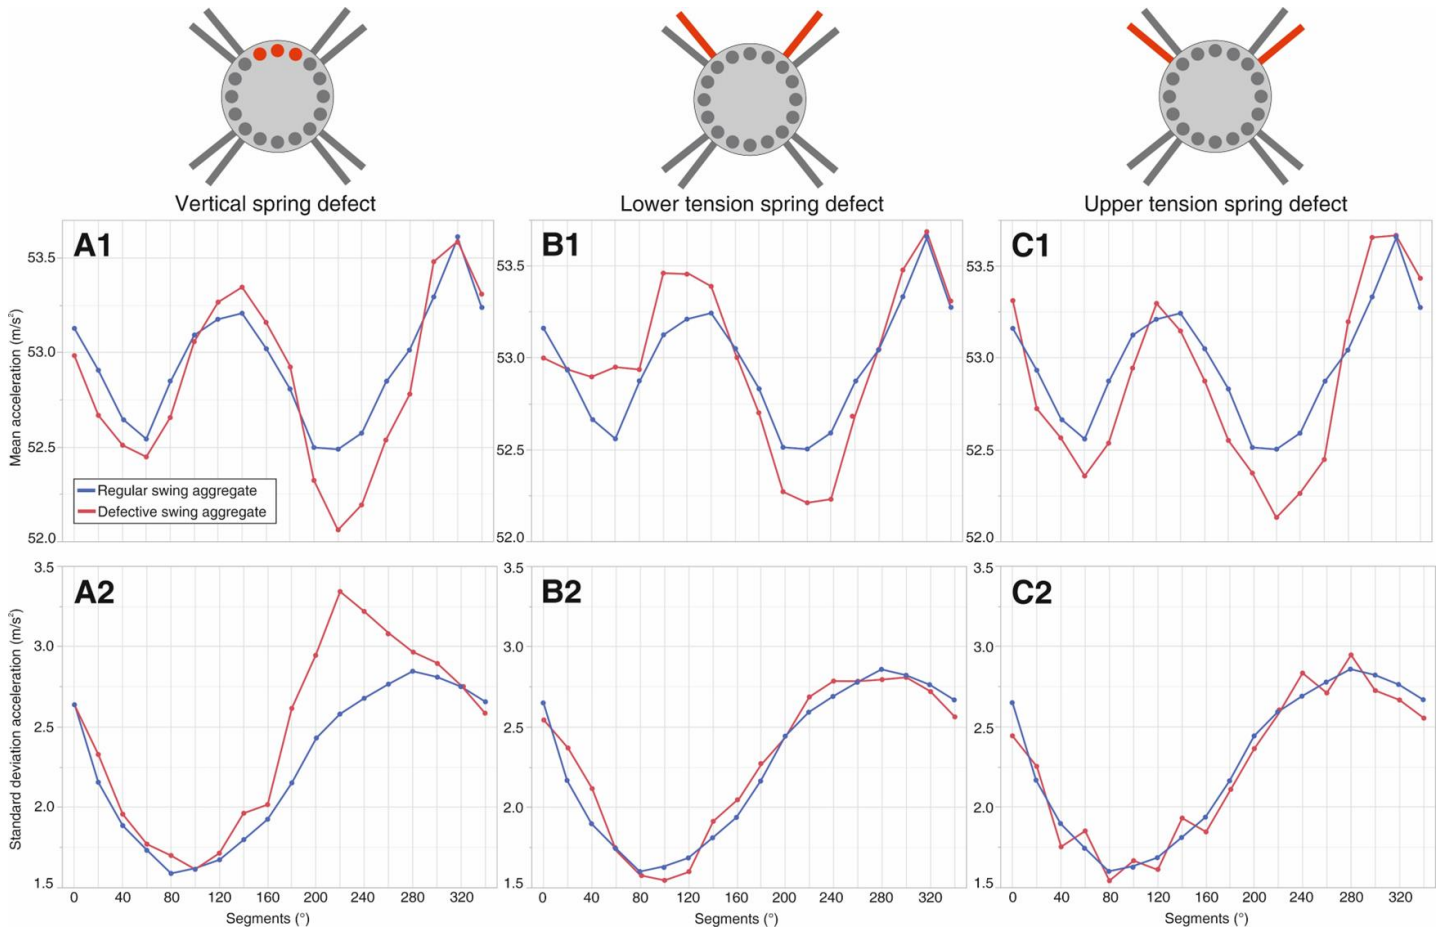
Figure 4: Graphs showing the mean average acceleration (upper row) and standard deviation (lower row) in the different motion path segments. The graphs for normal conditions are displayed in blue, for fault conditions in red.

Acceleration values ranged between 52.5 and 53.5 m/s², with sinusoidal oscillations peaking at 140° and 320°. Standard deviation values ranged between 1.5 and 3.0 m/s², with a minimum at 80° and a maximum at 280° (Figure 4, A-C, blue graphs).

Introducing three worn vertical springs caused a decrease in acceleration between 200° and 280°, accompanied by increased variability in the same segment (Figure 4, A1 and A2).

Using worn lower tension springs resulted in reduced acceleration between 200° and 280° (Figure 4, B1). Simultaneously, an increase in

acceleration was observed in the opposite segments (80°–140°). Standard deviation remained unaffected (Figure 4, B2).

Worn upper tension springs also reduced acceleration between 200° and 280° and caused a secondary reduction in the opposite segments (Figure 4, C1). Standard deviation values were unchanged (Figure 4, C2).
